**Flood Control Project Maintenance
Levee Inspections**

Fall 2015 Levee Maintenance Deficiency Summary Report

Sacramento River Basin

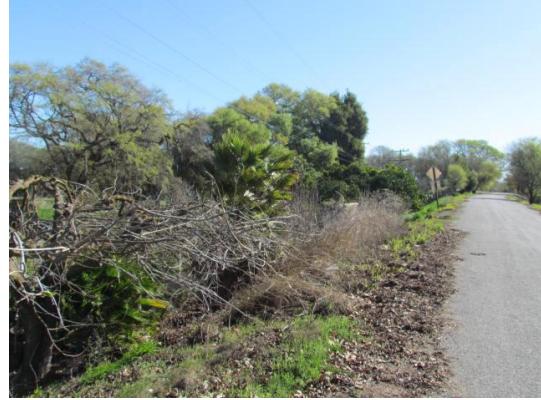
Photo 3 of 3 : FA_2015_RD0999_236_2_20150914_00003.jpg

Looking south at landscaping on landward slope.

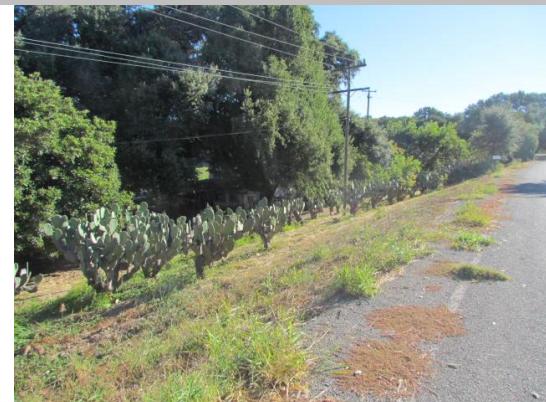
Photo 1 of 1 : FA_2015_RD0999_236_149_20150914_00100.jpg

LM Start	1.38	Rating **	M	Issue No.	149											
LM End	1.41	Issue Type +	En	Location *	LS											
Category	Earthen Levee			GPS Latitude/Longitude												
				Start	End											
Item	Vegetation			°	°											
				°	°											
DWR ID	DWR_RD0999_05_f_2013_149							Action/Comments								
Landscaping																
Inspector Comments: Large cactus plants on landward slope.

Looking northwest at several cactus plants on landward slope.

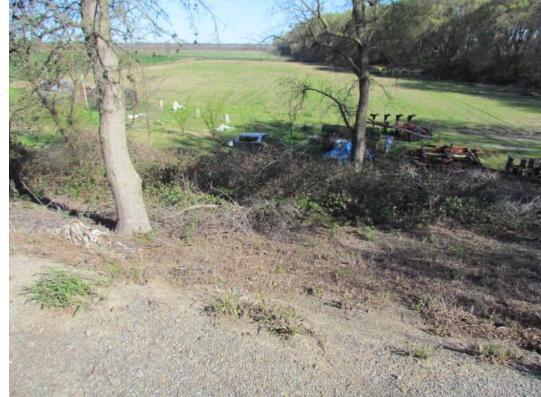
Photo 1 of 2 : FA_2015_RD0999_236_129_20150914_00090.jpg

LM Start	1.39	Rating **	M	Issue No.	129										
LM End	1.39	Issue Type +	Ma	Location *	LS										
Category	Earthen Levee			GPS Latitude/Longitude											
				Start	End										
Item	Vegetation			38.348100 °	38.348100 °										
				-121.574075 °	-121.574075 °										
DWR ID	DWR_RD0999_05_s_2012_129														
Action/Comments															
Remove the wild growth other than native grasses from the levee slopes. Inspector Comments: Berry vines and century plants on landside toe and slope.

Looking southwest at berry vines on landward slope.

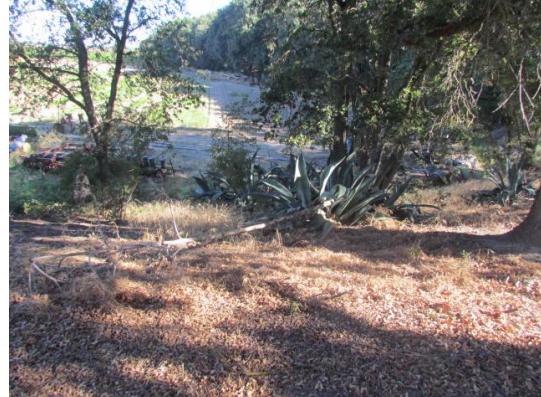
Photo 2 of 2 : FA_2015_RD0999_236_129_20150914_00091.jpg

Looking west at century plants on landward slope.

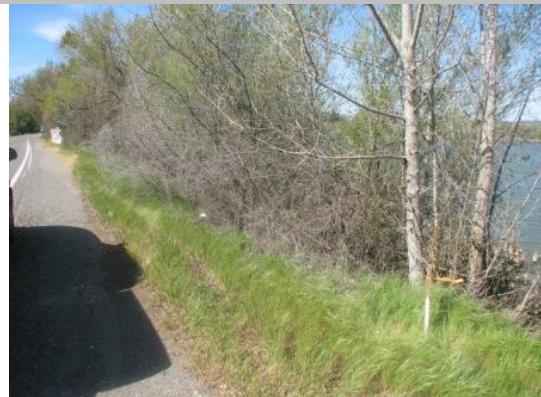
Photo 1 of 2 : FA_2015_RD0999_236_18_20150914_00019.jpg

Side view of dense trees along waterside slope.

LM Start	1.46	Rating **	M	Issue No.	18										
LM End	1.83	Issue Type +	Ma	Location *	LS										
Category	Earthen Levee			GPS Latitude/Longitude											
				Start	End										
Item	Trim / Thin Trees			38.348670 °	38.353852 °										
				-121.573320 °	-121.573570 °										
DWR ID	DWR_RD0999_05_s_2012_18														
Action/Comments															
Trim and thin trees to allow visibility of the ground and room to flood fight.

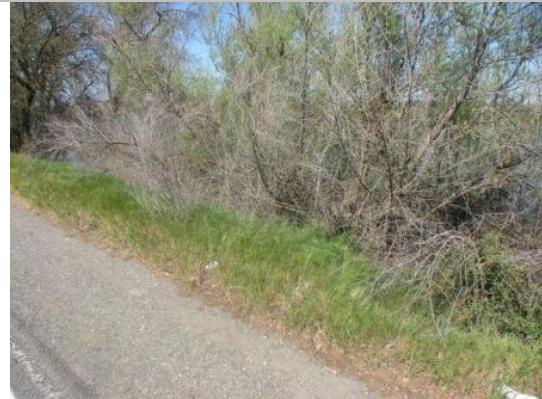
Photo 2 of 2 : FA_2015_RD0999_236_18_20150914_00020.jpg

Front view of dense trees along waterside slope.

LM Start	1.46	Rating **	M	Issue No.	18 (cont)				
LM End	1.83	Issue Type +	Ma	Location *	LS				
Category	Earthen Levee			GPS Latitude/Longitude					
				Start	End				
Item	Trim / Thin Trees			38.348670 °	38.353852 °				
				-121.573320 °	-121.573570 °				
DWR ID	DWR_RD0999_05_s_2012_18						Action/Comments		
Trim and thin trees to allow visibility of the ground and room to flood fight.

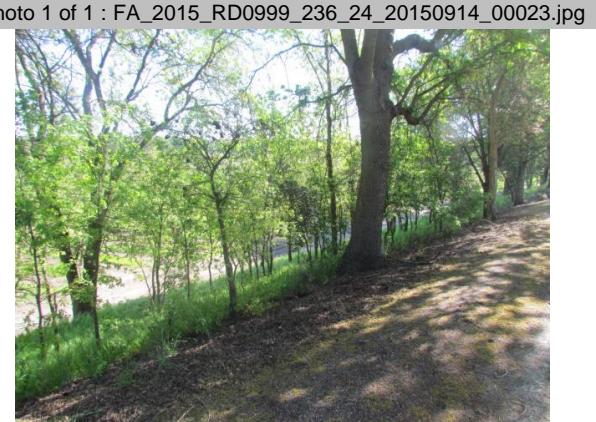
Looking west at dense trees on landward slope. (Spring 2015)

LM Start	2.14	Rating **	M	Issue No.	24									
LM End	2.16	Issue Type +	Ma	Location *	LS									
Category	Earthen Levee			GPS Latitude/Longitude										
				Start	End									
Item	Trim / Thin Trees			38.355402 °	38.355282 °									
				-121.568893 °	-121.568547 °									
DWR ID	DWR_RD0999_05_s_2012_24													
Action/Comments														
Trim and thin trees to allow visibility of the ground and room to flood fight.

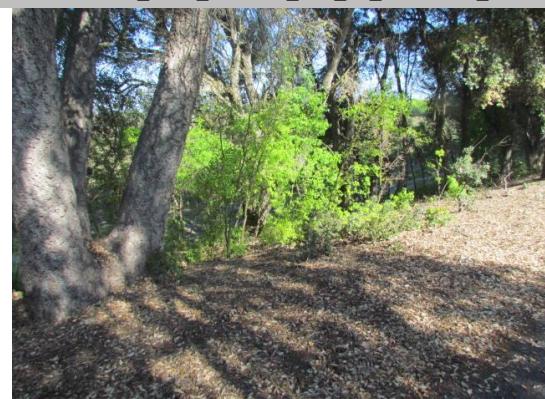
Looking northwest at dense trees on landward slope. (Spring 2015)

LM Start	2.51	Rating **	M	Issue No.	82	Photo 1 of 1 : FA_2015_RD0999_236_82_20150914_00069.jpg	
LM End	2.65	Issue Type +	Ma	Location *	LS		
Category Earthen Levee			GPS Latitude/Longitude				
			Start	End			
Item	Trim / Thin Trees			38.356270 °	38.358132 °		
				-121.563218 °	-121.562347 °		
DWR ID	DWR_RD0999_05_s_2012_82					Action/Comments	
Trim and thin trees to allow visibility of the ground and room to flood fight.

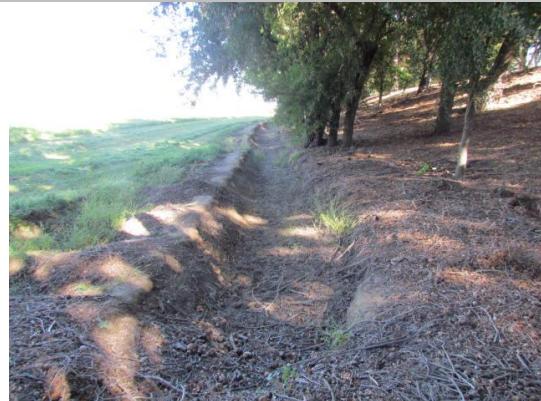
Photo 1 of 1 : FA_2015_RD0999_236_152_20150914_00101.jpg

LM Start	2.86	Rating **	M	Issue No.	152													
LM End	3.12	Issue Type +	En	Location *	LS													
Category	Earthen Levee			GPS Latitude/Longitude														
				Start	End													
Item	Encroachments			38.361047 °	38.364409 °													
				-121.563113 °	-121.561941 °													
DWR ID	DWR_RD0999_05_f_2013_152																	
Action/Comments																		
Ditch Inspector Comments: Irrigation ditch at landward toe.

Looking north at abandoned irrigation ditch at landward toe.

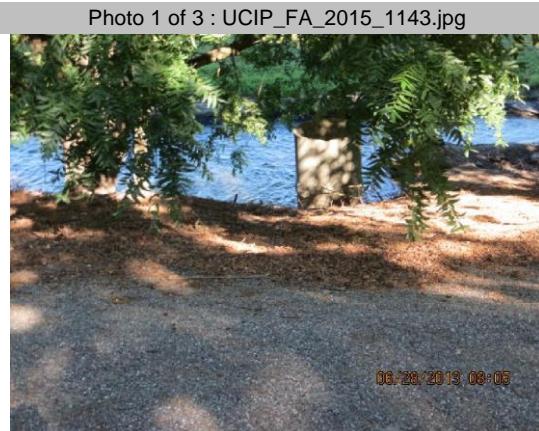
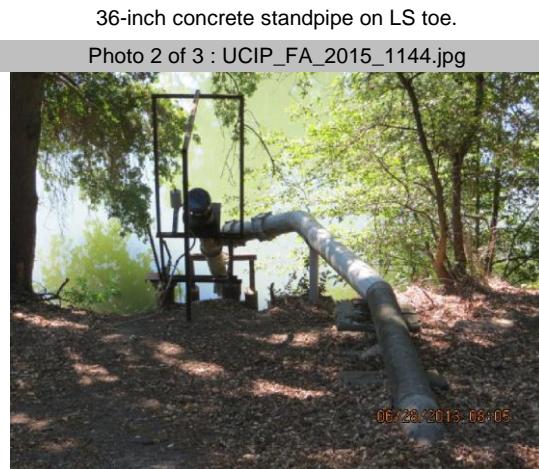
LM Start	3.02	Rating **	U	Issue No.	217												
LM End	3.02	Issue Type +	En	Location *	LS												
Category	Supplemental				GPS Latitude/Longitude												
					Start	End											
Item	DWR UCIP Field Study				38.363420 °	38.363420 °											
DWR ID					-121.563102 °	-121.563102 °											
Action/Comments																	
Inspector Comments: FS_ID:42936 DS_ID:22849 EP_NO: 7378 FS_HLM: 3.085 Repair Type: Urgent Crossing Status: Found UCIP Comments: Pipe outlet is eroding the LS slope of the levee, exposing the roots of an oak and threatening greater damage if allowed to continue. FIELD_STRUCT_DESC: 10-inch steel pipe through levee 6-feet below crown. Slant pump and service pole on the waterward slope. 36-inch concrete standpipe on LS toe (Permit No. 7378, 1971). Replaced an existing 8-inch pipe at the same location. FS Date: 06/28/2013

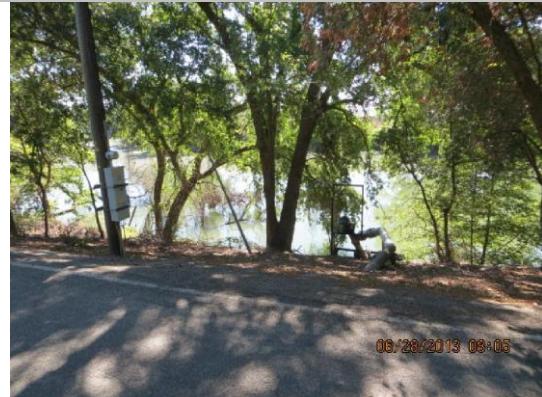
Photo 3 of 3 : UCIP_FA_2015_1145.jpg

LM Start	3.02	Rating **	U	Issue No.	217 (cont)									
LM End	3.02	Issue Type +	En	Location *	LS									
Category	Supplemental			GPS Latitude/Longitude										
				Start	End									
Item	DWR UCIP Field Study			38.363420 °	38.363420 °									
				-121.563102 °	-121.563102 °									
DWR ID														
Action/Comments														
Inspector Comments: FS_ID:42936 DS_ID:22849 EP_NO: 7378 FS_HLM: 3.085 Repair Type: Urgent Crossing Status: Found

Slant pump, JP, and meter on WS slope.

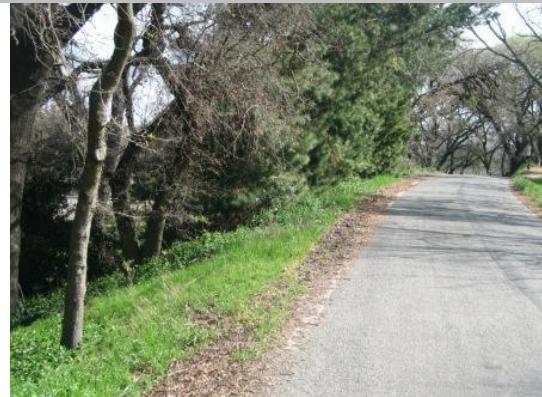
Photo 1 of 1 : FA_2015_RD0999_236_31_20150914_00030.jpg

LM Start	3.12	Rating **	M	Issue No.	31									
LM End	3.17	Issue Type +	En	Location *	LS									
Category	Earthen Levee			GPS Latitude/Longitude										
				Start	End									
Item	Vegetation			38.364392 °	38.364597 °									
				-121.561882 °	-121.561087 °									
DWR ID	DWR_RD0999_05_s_2012_31													
Action/Comments														
Landscaping

Looking downstream of landscaping blocking view of landside slope.

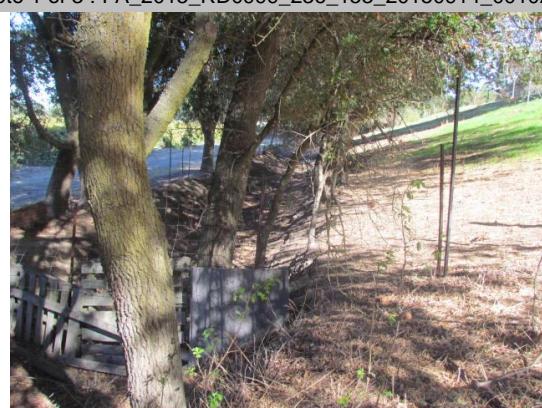
Photo 1 of 3 : FA_2015_RD0999_236_153_20150914_00102.jpg

LM Start	3.21	Rating **	M	Issue No.	153									
LM End	4.22	Issue Type +	En	Location *	LS									
Category	Earthen Levee			GPS Latitude/Longitude										
				Start	End									
Item	Encroachments			38.364694 °	38.372513 °									
				-121.560209 °	-121.552538 °									
DWR ID	DWR_RD0999_05_f_2013_153													
Action/Comments														
Ditch Inspector Comments: Adandoned irrigation ditch at landward toe.

Looking north at old irrigation ditch at landward toe.

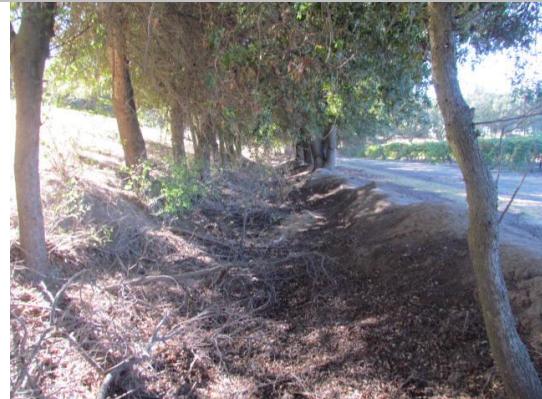
Photo 2 of 3 : FA_2015_RD0999_236_153_20150914_00103.jpg

Looking south at irrigation ditch at landward toe.

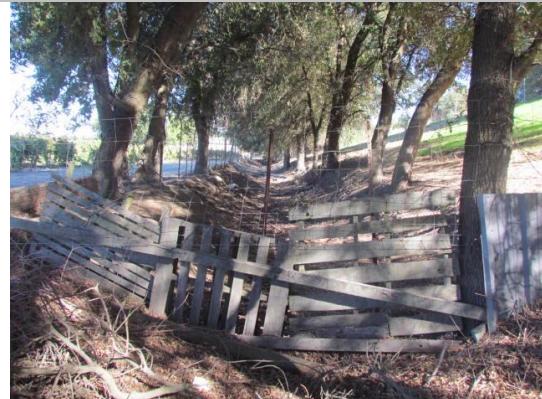
Photo 3 of 3 : FA_2015_RD0999_236_153_20150914_00104.jpg

Looking north at irrigation ditch at landward toe.

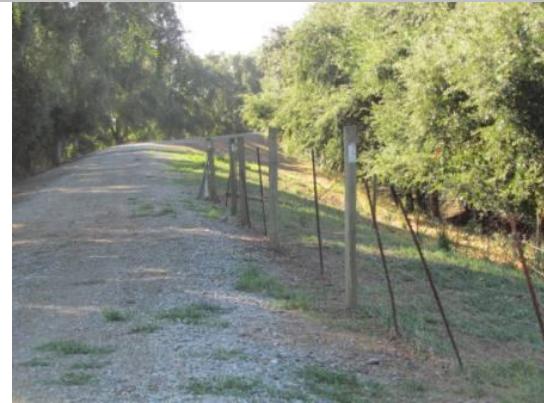
Photo 1 of 1 : FA_2015_RD0999_236_83_20150914_00070.jpg

LM Start	3.55	Rating **	M	Issue No.	83				
LM End	3.65	Issue Type +	En	Location *	LS				
Category	Earthen Levee			GPS Latitude/Longitude					
				Start	End				
Item	Encroachments			38.365711 °	38.367107 °				
				-121.556714 °	-121.556745 °				
DWR ID	DWR_RD0999_05_s_2012_83								
Action/Comments									
Fence	Inspector Comments: Fencing on landward slope.

Looking north at fence along waterside shoulder.

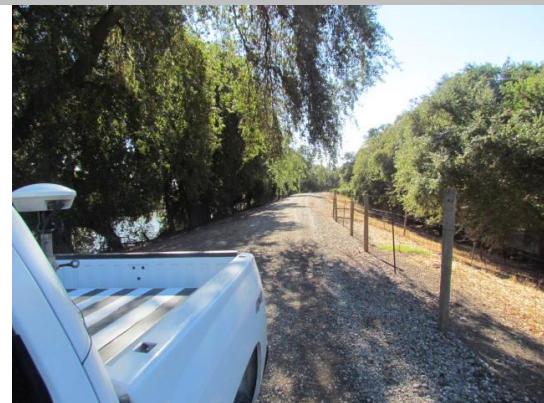
Photo 1 of 1 : FA_2015_RD0999_236_173_20151106_00158.jpg

Looking at the tree overhanging the levee crown.

LM Start	3.56	Rating **	M	Issue No.	173										
LM End	3.56	Issue Type +	Ma	Location *	WS										
Category	Earthen Levee			GPS Latitude/Longitude											
				Start	End										
Item	Trim / Thin Trees			38.365882 °	38.365882 °										
				-121.556762 °	-121.556762 °										
DWR ID	DWR_RD0999_05_f_2015_173														
Action/Comments															
Trim trees over roadway to at least 12 feet above ground level.

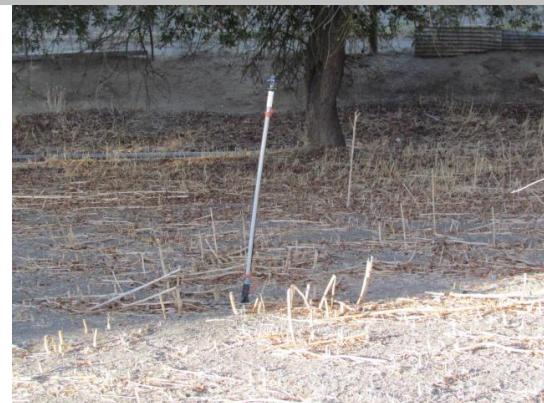
Photo 1 of 1 : FA_2015_RD0999_236_202_20150914_00124.jpg

LM Start	3.58	Rating **	M	Issue No.	202										
LM End	3.64	Issue Type +	En	Location *	LS										
Category	Earthen Levee			GPS Latitude/Longitude											
				Start	End										
Item	Encroachments			38.366100 °	38.367043 °										
				-121.556831 °	-121.556772 °										
DWR ID	DWR_RD0999_05_f_2014_202														
Action/Comments															
Landscape Irrigation Inspector Comments: Landowner installed sprinkler system on landward slope.

Looking west at one of several sprinklers installed on landward slope.

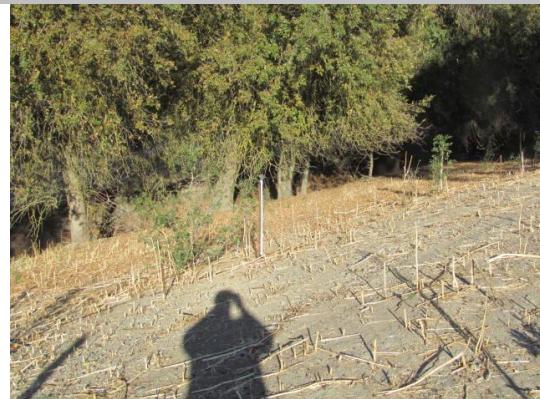
Photo 1 of 2 : FA_2015_RD0999_236_201_20150914_00122.jpg

LM Start	3.58	Rating **	M	Issue No.	201										
LM End	3.64	Issue Type +	Ma	Location *	LS										
Category	Earthen Levee		GPS Latitude/Longitude												
			Start	End											
Item	Trim / Thin Trees		38.366103 °	38.367035 °											
			-121.556820 °	-121.556781 °											
DWR ID	DWR_RD0999_05_f_2014_201														
Action/Comments															
Thin trees to allow visibility of the ground and room to flood fight. Inspector Comments: Landowner has planted oak trees and installed sprinklers on landward slope. Oak trees should be removed.

Looking west at several small oak trees planted on landward slope.

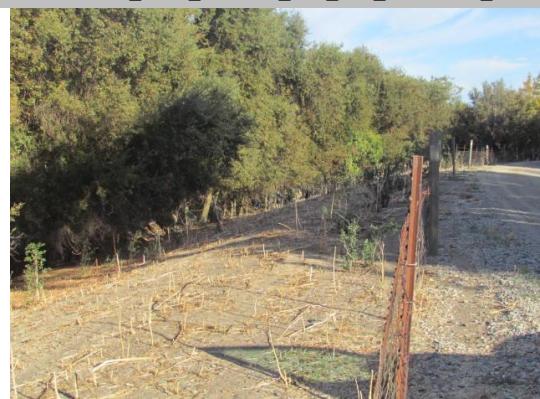
Photo 2 of 2 : FA_2015_RD0999_236_201_20150914_00123.jpg

Looking northwest at several small oak trees planted along landward slope.

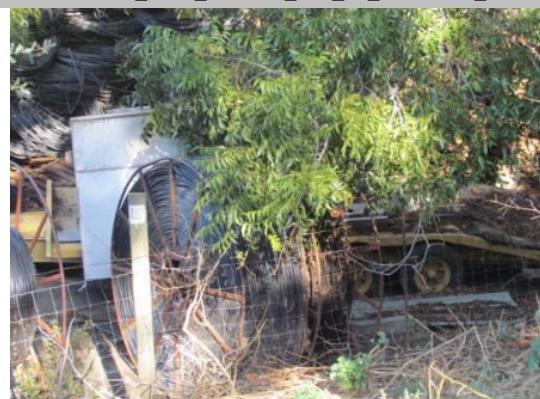
Photo 1 of 2 : FA_2015_RD0999_236_16_20150914_00015.jpg

LM Start	3.64	Rating **	M	Issue No.	16										
LM End	3.64	Issue Type +	Ma	Location *	LS										
Category	Earthen Levee		GPS Latitude/Longitude												
			Start	End											
Item	Encroachments		38.366958 °	38.366958 °											
			-121.556822 °	-121.556822 °											
DWR ID	DWR_RD0999_05_s_2012_16														
Action/Comments															
Equipment Inspector Comments: Equipment stored at landward toe.

Looking northwest at equipment on landside toe.

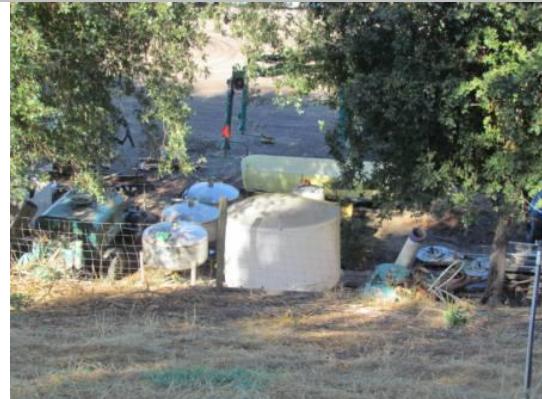
Photo 2 of 2 : FA_2015_RD0999_236_16_20150914_00016.jpg

LM Start	3.64	Rating **	M	Issue No.	16 (cont)															
LM End	3.64	Issue Type +	Ma	Location *	LS															
Category	Earthen Levee			GPS Latitude/Longitude																
				Start	End															
Item	Encroachments			38.366958 °	38.366958 °															
				-121.556822 °	-121.556822 °															
DWR ID	DWR_RD0999_05_s_2012_16																			
Action/Comments																				
Equipment Inspector Comments: Equipment stored at landward toe.

Looking west at equipment at landside toe.

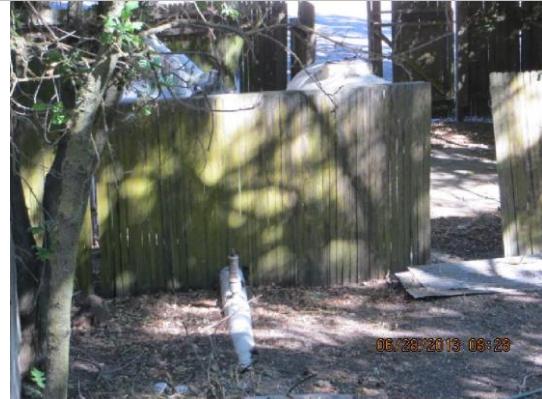
Photo 1 of 3 : UCIP_FA_2015_1370.jpg

LM Start	3.67	Rating **	M	Issue No.	218												
LM End	3.67	Issue Type +	En	Location *	LS												
Category	Supplemental			GPS Latitude/Longitude													
				Start	End												
Item	DWR UCIP Field Study			38.367469 °	38.367469 °												
				-121.556509 °	-121.556509 °												
DWR ID																	
Action/Comments																	
Inspector Comments: FS_ID:16337 DS_ID:23965 EP_NO: N/A FS_HLM: 3.743 Repair Type: Non-Urgent Crossing Status: Found UCIP Comments: Need to determine permit No. for this crossing. FIELD_STRUCT_DESC: 9-inch steel irrigation pipe through levee 2-feet below crown. Pump on pier on WS with butterfly valve. Filter plant and siphon breaker on LS toe 1.5-inch galvanized iron electrical at same location. FS Date: 06/28/2013

Siphon breaker and filter plant on LS toe.

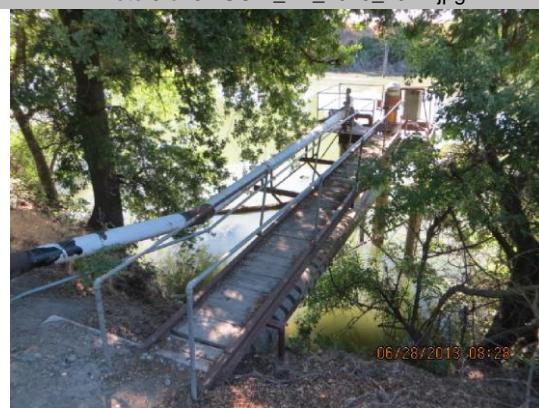
Pump on pier at WS.

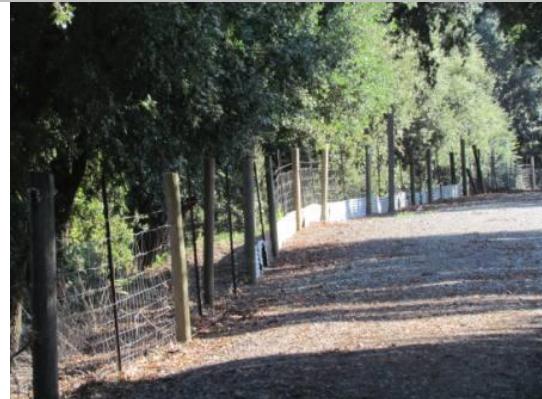
Photo 1 of 2 : FA_2015_RD0999_236_85_20150914_00071.jpg

LM Start	3.68	Rating **	M	Issue No.	85										
LM End	3.75	Issue Type +	En	Location *	LS										
Category	Earthen Levee		GPS Latitude/Longitude												
			Start	End											
Item	Encroachments		38.367500 °	38.367997 °											
			-121.556478 °	-121.555348 °											
DWR ID	DWR_RD0999_05_s_2012_85														
Action/Comments															
Fence Inspector Comments: Fencing is for livestock.

Looking north at fence along landside shoulder.

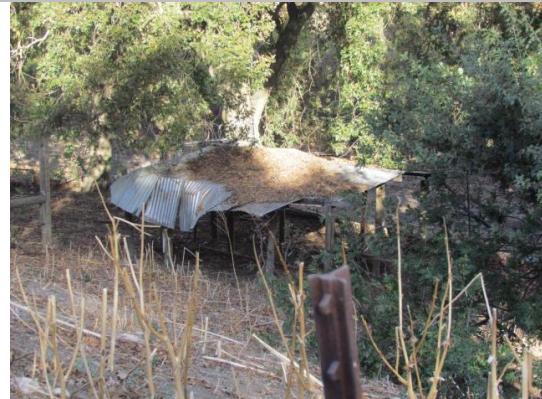
Photo 2 of 2 : FA_2015_RD0999_236_85_20150914_00072.jpg

Looking west at animal shelter within animal pen on landward slope.

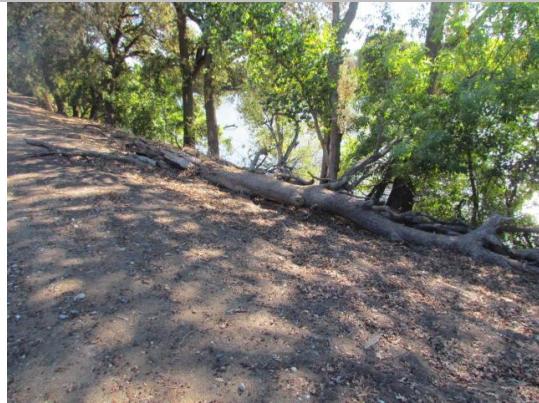
Photo 1 of 1 : FA_2015_RD0999_236_174_20151106_00159.jpg

LM Start	3.80	Rating **	M	Issue No.	174							
LM End	3.80	Issue Type +	Ma	Location *	WS							
Category	Earthen Levee		GPS Latitude/Longitude									
			Start	End								
Item	Encroachments		38.368207 °	38.368207 °	-121.554360 °	-121.554360 °						
DWR ID	DWR_RD0999_05_f_2015_174											
Action/Comments												
Tree or limb Inspector Comments: Downed tree branch and limbs on waterward slope.

Looking at downed tree branch on waterward slope.

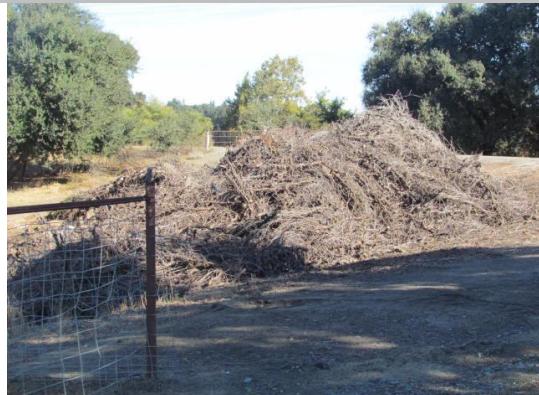
Photo 1 of 3 : FA_2015_RD0999_236_17_20151106_00160.jpg

LM Start	3.88	Rating **	U	Issue No.	17							
LM End	3.88	Issue Type +	En	Location *	LS							
Category	Earthen Levee		GPS Latitude/Longitude									
			Start	End								
Item	Encroachments		38.368307 °	38.368307 °	-121.552955 °	-121.552955 °						
DWR ID	DWR_RD0999_05_s_2012_17											
Action/Comments												
Prunings Inspector Comments: Large pruning pile on landward toe and slope.

Looking northwest at large pruning pile on landward slope and berm. Fall 2015.

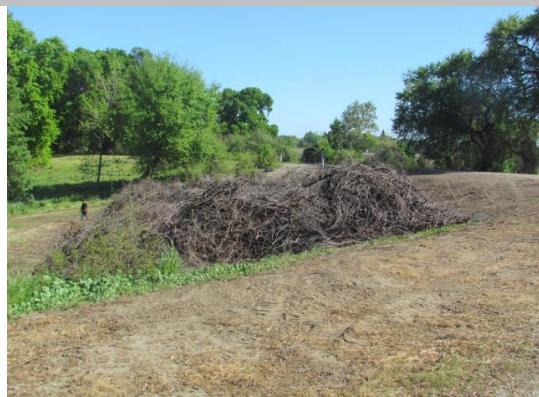
Photo 2 of 3 : FA_2015_RD0999_236_17_20150914_00017.jpg

Looking northwest at large pruning pile on landward slope and berm.
(Spring 2015)

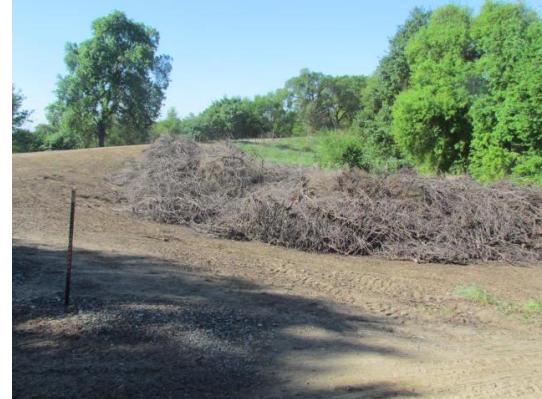
Photo 3 of 3 : FA_2015_RD0999_236_17_20150914_00018.jpg

LM Start	3.88	Rating **	U	Issue No.	17 (cont)									
LM End	3.88	Issue Type +	En	Location *	LS									
Category	Earthen Levee			GPS Latitude/Longitude										
				Start	End									
Item	Encroachments			38.368307 °	38.368307 °									
				-121.552955 °	-121.552955 °									
DWR ID	DWR_RD0999_05_s_2012_17													
Action/Comments														
Prunings Inspector Comments: Large pruning pile on landward toe and slope.

Looking southwest at large pruning pile on landward slope and berm.
(Spring 2015)

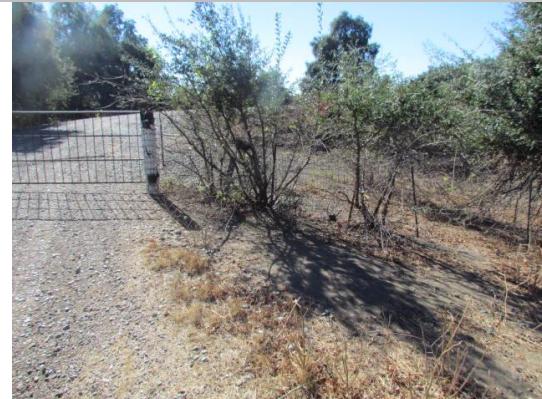
Photo 1 of 1 : FA_2015_RD0999_236_175_20151106_00161.jpg

LM Start	3.94	Rating **	M	Issue No.	175									
LM End	3.94	Issue Type +	Ma	Location *	LS									
Category	Earthen Levee			GPS Latitude/Longitude										
				Start	End									
Item	Trim / Thin Trees			38.368928 °	38.368928 °									
				-121.552473 °	-121.552473 °									
DWR ID	DWR_RD0999_05_f_2015_175													
Action/Comments														
Thin trees to allow visibility of the ground and room to flood fight. Inspector Comments: Thin or remove young tree from landward shoulder and slope.

Looking at young trees on waterward shoulder and slope.

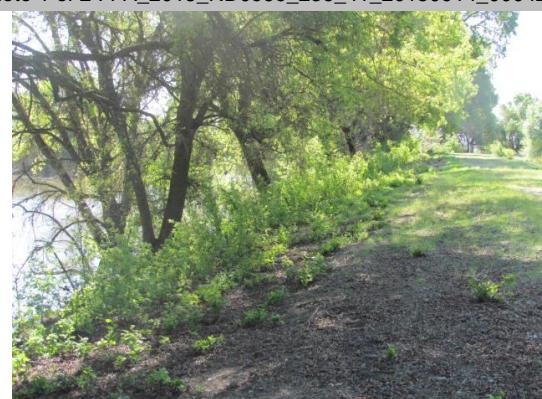
Photo 1 of 2 : FA_2015_RD0999_236_41_20150914_00042.jpg

LM Start	3.98	Rating **	M	Issue No.	41									
LM End	4.05	Issue Type +	Ma	Location *	WS									
Category	Earthen Levee			GPS Latitude/Longitude										
				Start	End									
Item	Trim / Thin Trees			38.369440 °	38.370398 °									
				-121.552747 °	-121.553373 °									
DWR ID	DWR_RD0999_05_s_2012_41													
Action/Comments														
Trim and thin trees to allow visibility of the ground and room to flood fight. Inspector Comments: Control oak saplings on waterward slope.

Looking southeast at saplings on waterward slope. (Spring 2015)

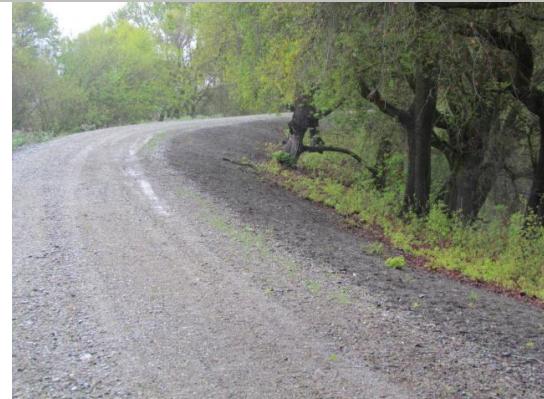
Photo 2 of 2 : FA_2015_RD0999_236_41_20150914_00043.jpg

LM Start	3.98	Rating **	M	Issue No.	41 (cont)												
LM End	4.05	Issue Type +	Ma	Location *	WS												
Category	Earthen Levee			GPS Latitude/Longitude													
				Start	End												
Item	Trim / Thin Trees			38.369440 °	38.370398 °												
				-121.552747 °	-121.553373 °												
DWR ID	DWR_RD0999_05_s_2012_41																
Action/Comments																	
Trim and thin trees to allow visibility of the ground and room to flood fight. Inspector Comments: Control oak saplings on waterward slope.

Looking northeast at trimmed trees on waterside slope.

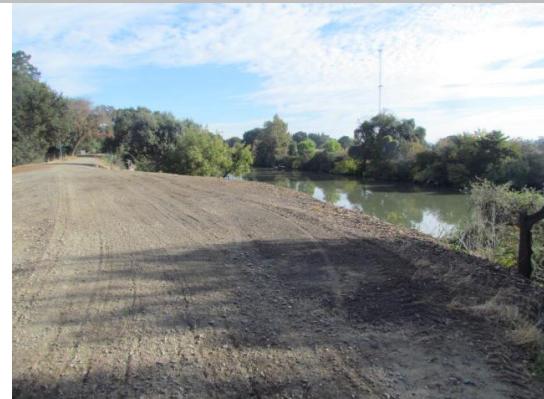
Photo 1 of 2 : FA_2015_RD0999_236_35_20150914_00032.jpg

LM Start	4.23	Rating **	A/W	Issue No.	35												
LM End	4.23	Issue Type +	En	Location *	WS												
Category	Earthen Levee			GPS Latitude/Longitude													
				Start	End												
Item	Encroachments			38.372672 °	38.372672 °												
				-121.552380 °	-121.552380 °												
DWR ID	DWR_RD0999_05_s_2012_35																
Action/Comments																	
Prunings

Looking northeast at corrected pruning site on waterward shoulder and slope.

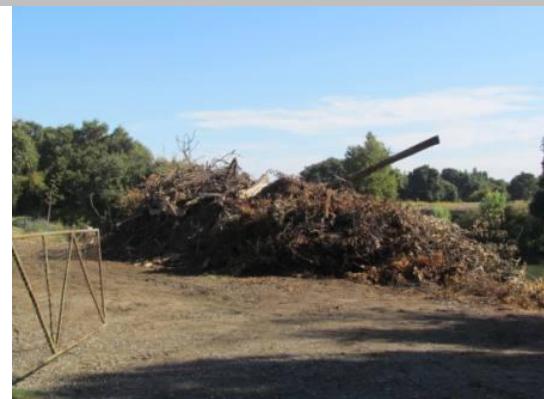
Photo 2 of 2 : FA_2015_RD0999_236_35_20150914_00033.jpg

Looking northeast at larger pruning pile on waterside shoulder.

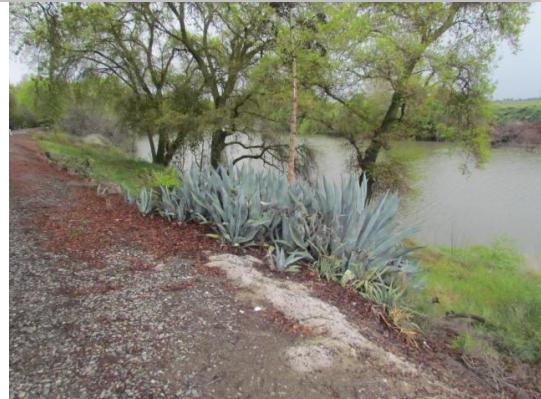
Photo 1 of 1 : FA_2015_RD0999_236_55_20150914_00055.jpg

LM Start	4.29	Rating **	M	Issue No.	55										
LM End	4.29	Issue Type +	En	Location *	WS										
Category	Earthen Levee			GPS Latitude/Longitude											
				Start	End										
Item	Vegetation			38.373517 °	38.373517 °										
				-121.551867 °	-121.551867 °										
DWR ID	DWR_RD0999_05_s_2012_55														
Action/Comments															
Landscaping Inspector Comments: Century plant on waterside slope.

Looking at century plants on waterside shoulder.(Spring 2012)

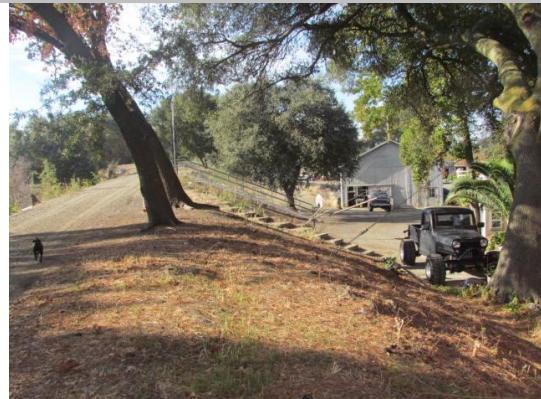
Photo 1 of 4 : FA_2015_RD0999_236_44_20150914_00046.jpg

LM Start	4.30	Rating **	A/W	Issue No.	44										
LM End	4.33	Issue Type +	En	Location *	LS										
Category	Earthen Levee			GPS Latitude/Longitude											
				Start	End										
Item	Vegetation			38.373625 °	38.373907 °										
				-121.551787 °	-121.551607 °										
DWR ID	DWR_RD0999_05_s_2012_44														
Action/Comments															
Landscaping Inspector Comments: Landowner complies with Board standards.

Looking south at corrected landscaping on landward slope.

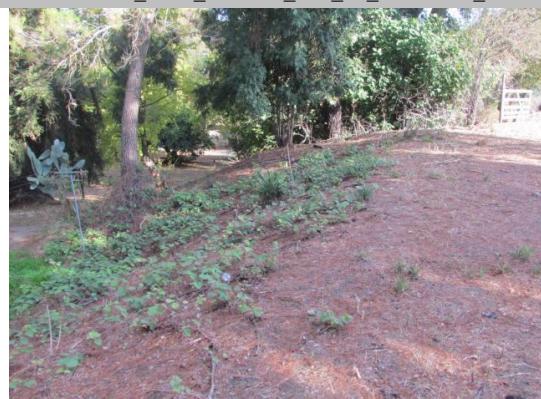
Photo 2 of 4 : FA_2015_RD0999_236_44_20150914_00047.jpg

Looking north at corrected landscaping on landward slope.

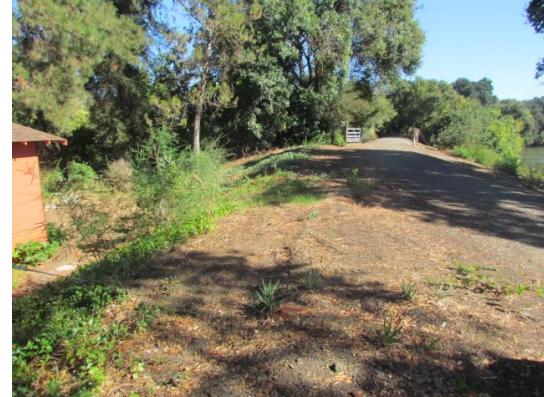
Photo 3 of 4 : FA_2015_RD0999_236_44_20150914_00048.jpg

LM Start	4.30	Rating **	A/W	Issue No.	44 (cont)										
LM End	4.33	Issue Type +	En	Location *	LS										
Category	Earthen Levee			GPS Latitude/Longitude											
				Start	End										
Item	Vegetation			38.373625 °	38.373907 °										
				-121.551787 °	-121.551607 °										
DWR ID	DWR_RD0999_05_s_2012_44														
Action/Comments															
Landscaping Inspector Comments: Landowner complies with Board standards.

Looking north at landscaping on landward slope.

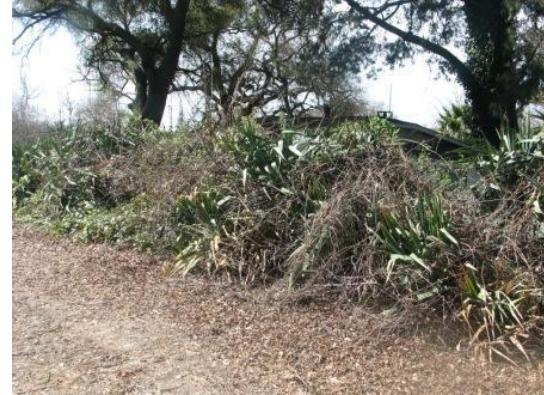
Photo 4 of 4 : FA_2015_RD0999_236_44_20150914_00049.jpg

Overgrown landscaping on landside slope blocking view of slope.

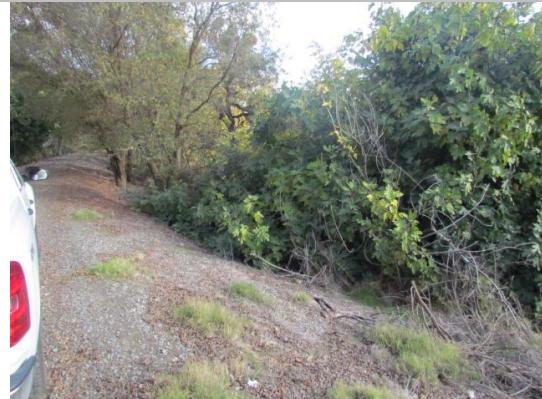
Photo 1 of 1 : FA_2015_RD0999_236_28_20150914_00029.jpg

LM Start	4.35	Rating **	A/W	Issue No.	28										
LM End	4.35	Issue Type +	Ma	Location *	WS										
Category	Earthen Levee			GPS Latitude/Longitude											
				Start	End										
Item	Vegetation			38.374215 °	38.374215 °										
				-121.551352 °	-121.551352 °										
DWR ID	DWR_RD0999_05_f_2012_28														
Action/Comments															
Remove the wild growth other than native grasses from the levee slopes.

Looking northeast at fig tree on waterside slope.

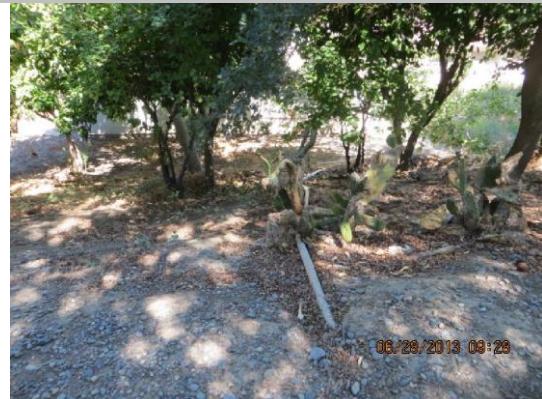
Photo 1 of 2 : UCIP_FA_2015_1373.jpg

LM Start	4.36	Rating **	M	Issue No.	219										
LM End	4.36	Issue Type +	En	Location *	WS										
Category	Supplemental			GPS Latitude/Longitude											
				Start	End										
Item	DWR UCIP Field Study			38.374376 °	38.374376 °										
				-121.551201 °	-121.551201 °										
DWR ID															
Action/Comments															
Inspector Comments: FS_ID:16338 DS_ID:23966 EP_NO: N/A FS_HLM: 4.44 Repair Type: Non-Urgent Crossing Status: Found UCIP Comments: This crossing should be permitted or removed. FIELD_STRUCT_DESC: 2-inch plastic water line through the levee 6-inch below the crown. Portable pump on the WS toe. FS Date: 06/28/2013

Flex pipe visible on LS shoulder.

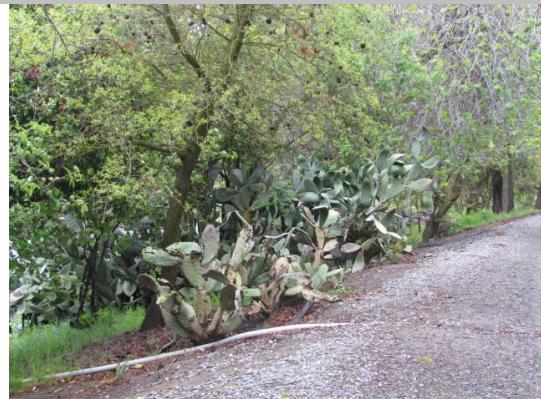
Photo 1 of 1 : FA_2015_RD0999_236_56_20150914_00056.jpg

LM Start	4.37	Rating **	M	Issue No.	56										
LM End	4.37	Issue Type +	En	Location *	LS										
Category	Earthen Levee			GPS Latitude/Longitude											
				Start	End										
Item	Vegetation			38.374410 °	38.374410 °										
				-121.551173 °	-121.551173 °										
DWR ID	DWR_RD0999_05_s_2012_56														
Action/Comments															
Landscaping Inspector Comments: Cactus

Looking northwest at cactus on landside shoulder and slope. (Spring 2012)

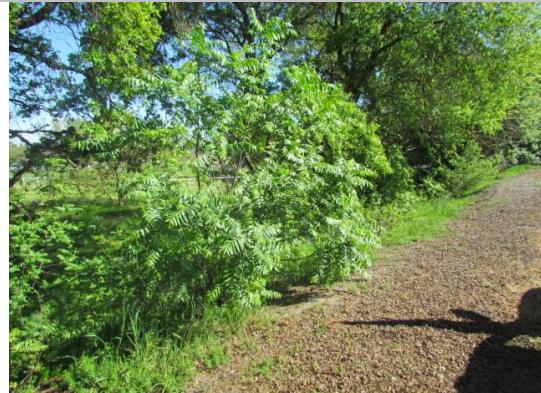
Photo 1 of 1 : FA_2015_RD0999_236_57_20150914_00057.jpg

LM Start	4.42	Rating **	M	Issue No.	57										
LM End	4.46	Issue Type +	Ma	Location *	LS										
Category	Earthen Levee			GPS Latitude/Longitude											
				Start	End										
Item	Trim / Thin Trees			38.374866 °	38.375061 °										
				-121.550491 °	-121.549800 °										
DWR ID	DWR_RD0999_05_s_2012_57														
Action/Comments															
Trim and thin trees to allow visibility of the ground and room to flood fight.

Looking northwest at dense trees on landward slope. (Spring 2015)

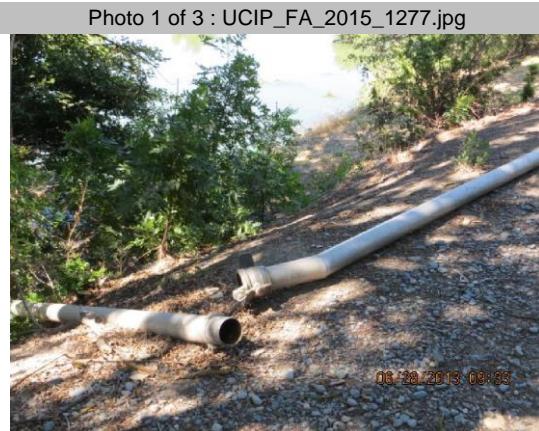
LM Start	4.45	Rating **	M	Issue No.	220																	
LM End	4.45	Issue Type +	En	Location *	LS																	
Category				GPS Latitude/Longitude																		
				Start	End																	
Item				38.375036 °	38.375036 °																	
				-121.549961 °	-121.549961 °																	
DWR ID																						
Action/Comments																						
Inspector Comments: FS_ID:16403 DS_ID:23967 EP_NO: N/A FS_HLM: 4.52 Repair Type: Non-Urgent Crossing Status: Found UCIP Comments: Need to determine Permit No. for this crossing or remove it. FIELD_STRUCT_DESC: 5-inch temporary alluminum pipe over the top of the levee. Portable pump on the WS toe. FS Date: 06/28/2013

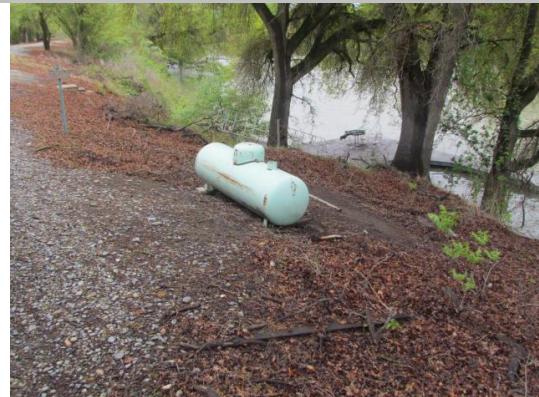
Photo 1 of 1 : FA_2015_RD0999_236_131_20150914_00092.jpg

LM Start	4.45	Rating **	M	Issue No.	131									
LM End	4.45	Issue Type +	En	Location *	WS									
Category	Earthen Levee			GPS Latitude/Longitude										
				Start	End									
Item	Encroachments			38.375027 °	38.375027 °									
				-121.549883 °	-121.549883 °									
DWR ID	DWR_RD0999_05_s_2012_131													
Action/Comments														
Equipment Inspector Comments: Propane tank on waterside slope within the twenty foot zone.

Looking northeast at propane tank on waterside slope.

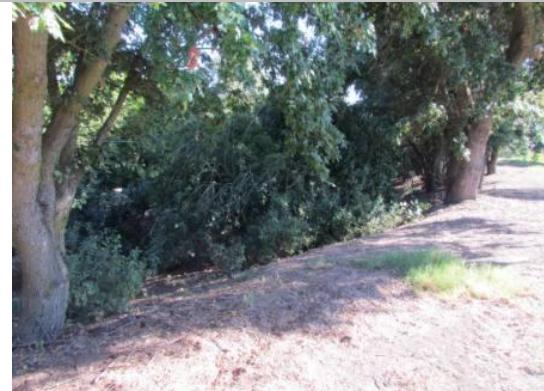
Photo 1 of 3 : FA_2015_RD0999_236_38_20150914_00034.jpg

Looking northwest at dense trees on landside slope. (Spring 2011)

LM Start	4.51	Rating **	A/W	Issue No.	38																	
LM End	4.64	Issue Type +	Ma	Location *	LS																	
Category	Earthen Levee				GPS Latitude/Longitude																	
					Start	End																
Item	Trim / Thin Trees				38.375055 °	38.375313 °																
DWR ID	DWR_RD0999_05_s_2012_38																					
Action/Comments																						
Thin trees to allow visibility of the ground and room to flood fight.

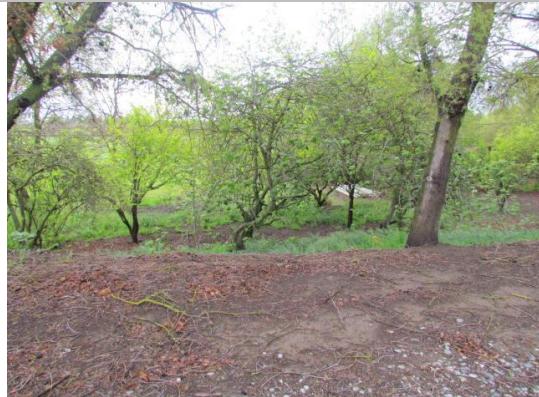
Photo 2 of 3 : FA_2015_RD0999_236_38_20150914_00035.jpg

Looking west at trimmed trees on landside slope. (Spring 2012)

LM Start	4.51	Rating **	A/W	Issue No.	38 (cont)												
LM End	4.64	Issue Type +	Ma	Location *	LS												
Category	Earthen Levee			GPS Latitude/Longitude													
				Start	End												
Item	Trim / Thin Trees			38.375055 °	38.375313 °												
				-121.548792 °	-121.546438 °												
DWR ID	DWR_RD0999_05_s_2012_38																
Action/Comments																	
Thin trees to allow visibility of the ground and room to flood fight.

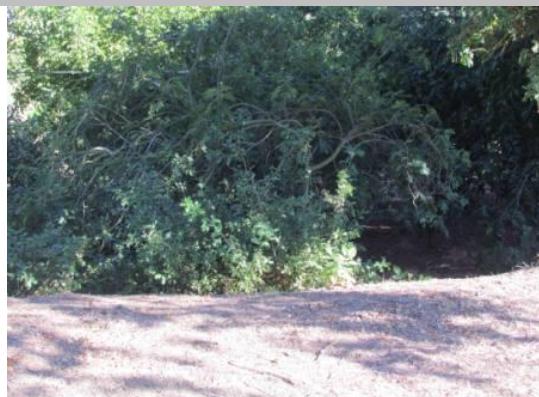
Photo 3 of 3 : FA_2015_RD0999_236_38_20150914_00036.jpg

Looking west at dense trees on landside slope. (Spring 2011)

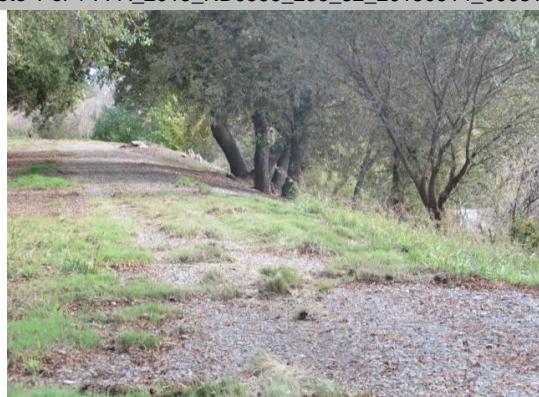
Photo 1 of 1 : FA_2015_RD0999_236_32_20150914_00031.jpg

Looking north at vegetation on levee crown.

LM Start	4.51	Rating **	M	Issue No.	32									
LM End	4.85	Issue Type +	Ma	Location *	CR									
Category	Earthen Levee			GPS Latitude/Longitude										
				Start	End									
Item	Crown Surface / Depressions / Rutting			38.375084 °	38.377176 °									
				-121.548750 °	-121.543571 °									
DWR ID	DWR_RD0999_05_f_2012_32													
Action/Comments														
Add appropriate material and re-grade the levee to bring the crown above the design elevation.

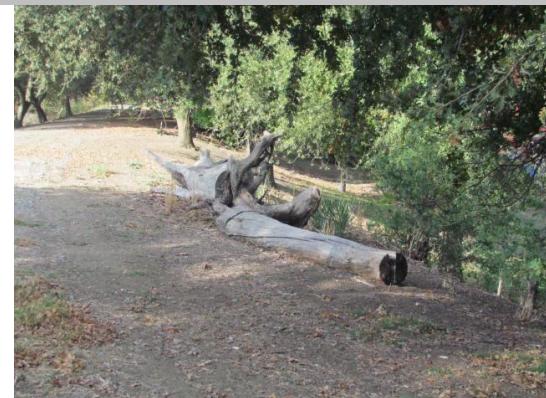
Photo 1 of 1 : FA_2015_RD0999_236_50_20150914_00052.jpg

LM Start	4.65	Rating **	A/W	Issue No.	50					
LM End	4.65	Issue Type +	Ma	Location *	LS					
Category	Earthen Levee			GPS Latitude/Longitude						
				Start	End					
Item	Encroachments			38.375373 °	38.375373 °					
				-121.546200 °	-121.546200 °					
DWR ID	DWR_RD0999_05_s_2012_50									
Action/Comments										
Tree or limb Inspector Comments: Old tree limbs on landward shoulder blocking access.

Looking southwest at tree limbs on landward shoulder.

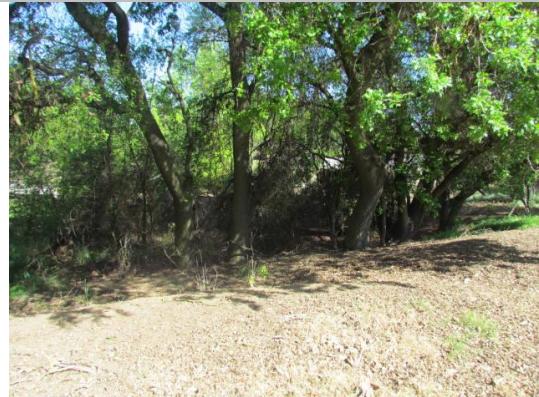
Photo 1 of 1 : FA_2015_RD0999_236_52_20150914_00054.jpg

Looking west at untrimmed trees on landward toe. (Spring 2015)

LM Start	4.67	Rating **	M	Issue No.	52										
LM End	4.67	Issue Type +	Ma	Location *	LS										
Category	Earthen Levee			GPS Latitude/Longitude											
				Start	End										
Item	Trim / Thin Trees			38.375478 °	38.375478 °										
				-121.545852 °	-121.545852 °										
DWR ID	DWR_RD0999_05_s_2012_52														
Action/Comments															
Trim trees to at least five feet above ground level.

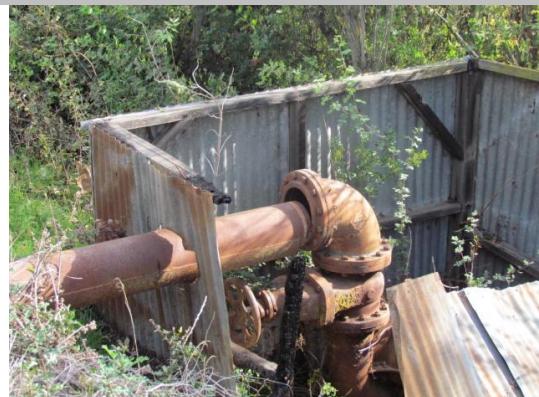
Photo 1 of 1 : FA_2015_RD0999_236_46_20150914_00050.jpg

LM Start	4.68	Rating **	M	Issue No.	46										
LM End	4.68	Issue Type +	Ma	Location *	WS										
Category	Earthen Levee			GPS Latitude/Longitude											
				Start	End										
Item	Encroachments			38.375548 °	38.375548 °										
				-121.545693 °	-121.545693 °										
DWR ID	DWR_RD0999_05_f_2012_46														
Action/Comments															
Pipe Inspector Comments: Pipe is disconnected from pump and should be reconnected or removed.

Looking east at pipe disconnected from pump.

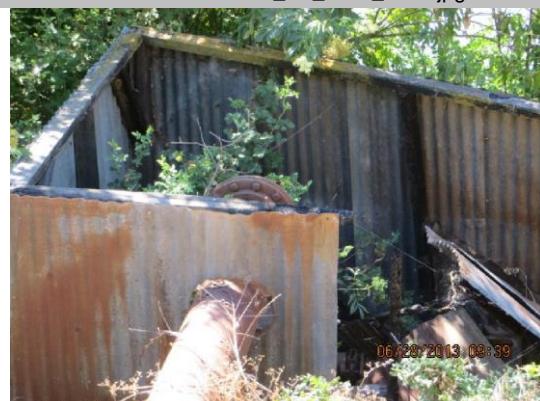
Item				38.375537 °	38.375537 °																			
				-121.545647 °	-121.545647 °																			
DWR ID																								
Action/Comments																								
Inspector Comments: FS_ID:15443 DS_ID:22882 EP_NO: 7383 FS_HLM: 4.766 Repair Type: Non-Urgent Crossing Status: Found UCIP Comments: Pipe abandoned and should be done so properly. FIELD_STRUCT_DESC: 10-inch steel irrigation pipe through the levee 4.0 feet below the crown. Pumphouse on WS slope and a JP on the LS shoulder. 1.5-inch galvanized iron electrical conduit at same location. Replaces existing portion of a 10-inch pipe within the levee section (Permit No. 7383, 1971). FS Date: 06/28/2013

Abandoned pumphouse on WS slope.

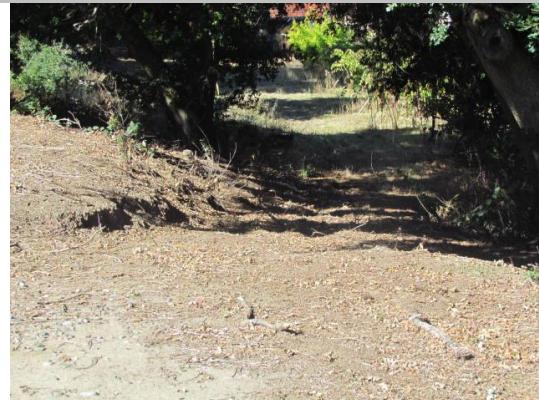
Photo 1 of 1 : FA_2015_RD0999_236_154_20150914_00105.jpg

LM Start	4.76	Rating **	A/W	Issue No.	154									
LM End	4.76	Issue Type +	Ma	Location *	LS									
Category	Earthen Levee			GPS Latitude/Longitude										
				Start	End									
Item	Slope Stability			38.376257 °	38.376257 °									
				-121.544578 °	-121.544578 °									
DWR ID	DWR_RD0999_05_f_2013_154													
Action/Comments														
Repair the levee slope damaged by vehicle traffic and prevent access where possible.														
Inspector Comments: Levee damaged by vehicle traffic.

Looking west at levee damage due to vehicle traffic.

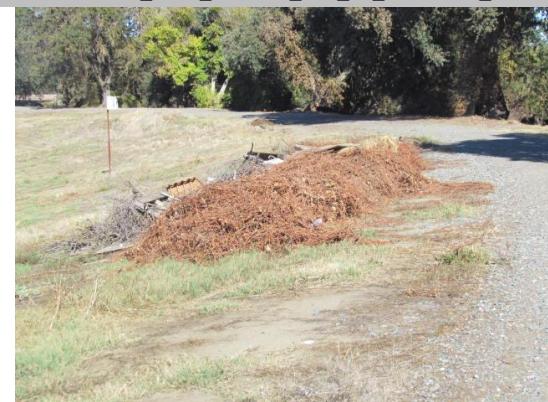
LM Start	5.07	Rating **	M	Issue No.	65		Photo 1 of 2 : FA_2015_RD0999_236_65_20151106_00162.jpg	
LM End	5.07	Issue Type +	Ma	Location *	LS			
Category	Earthen Levee			GPS Latitude/Longitude				
				Start	End			
Item	Encroachments			38.379711 °	38.379711 °			
				-121.541070 °	-121.541070 °			
DWR ID	DWR_RD0999_05_s_2012_65		Action/Comments					
			Prunings Inspector Comments: Prunings on landside slope.

Looking northwest at prunings on landward slope fall 2015

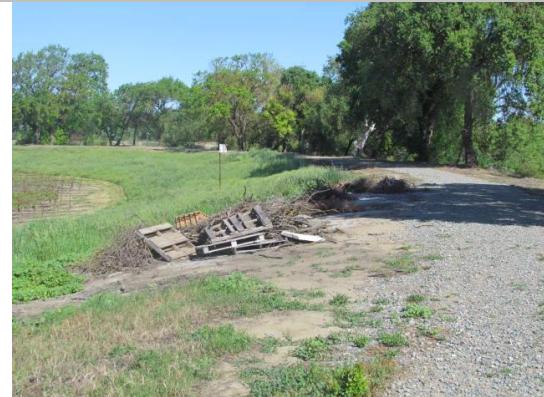
Photo 2 of 2 : FA_2015_RD0999_236_65_20150914_00059.jpg

Looking north at prunings on landward slope. (Spring 2015)

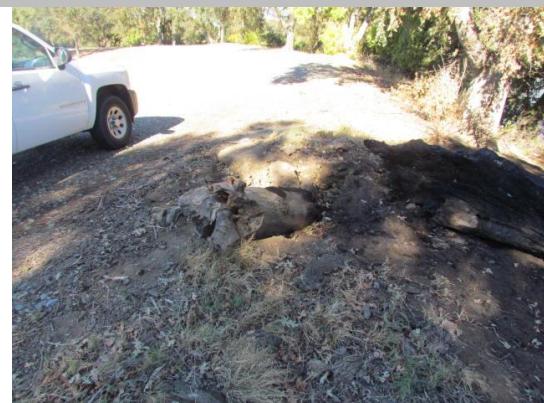
Photo 1 of 2 : FA_2015_RD0999_236_176_20151106_00163.jpg

LM Start	5.12	Rating **	U	Issue No.	176									
LM End	5.12	Issue Type +	Ma	Location *	WS									
Category	Earthen Levee			GPS Latitude/Longitude										
				Start	End									
Item	Slope Stability			38.380420 °	38.380420 °									
				-121.541102 °	-121.541102 °									
DWR ID	DWR_RD0999_05_f_2015_176													
Action/Comments														
Repair slope instability. Inspector Comments: Large hole on waterward shoulder caused by fallen tree.

Looking at hole on waterward shoulder caused by fallen tree.

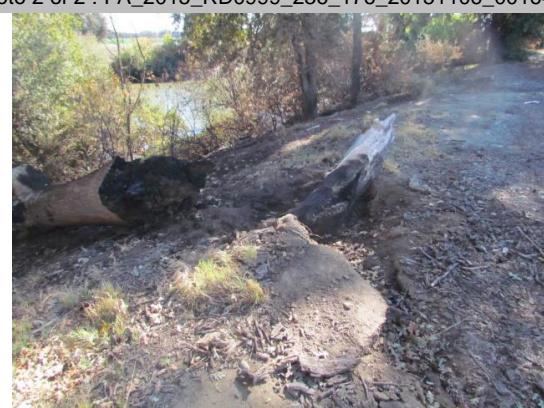
Photo 2 of 2 : FA_2015_RD0999_236_176_20151106_00164.jpg

Looking at fallen tree and hole on waterward slope and shoulder.

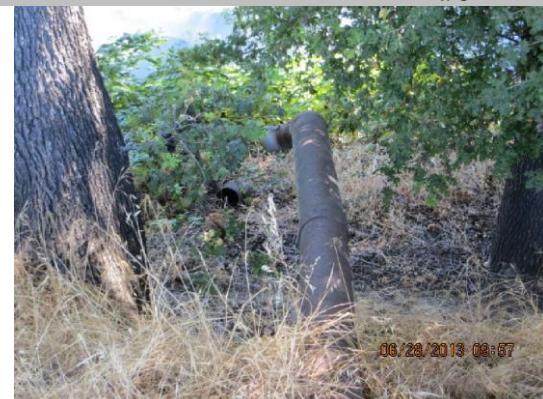
LM Start	5.13	Rating **	U	Issue No.	222																	
LM End	5.13	Issue Type +	En	Location *	WS																	
Category	Supplemental				GPS Latitude/Longitude																	
					Start	End																
Item	DWR UCIP Field Study				38.380523°	38.380523°																
					-121.541186°	-121.541186°																
DWR ID																						
Action/Comments																						
Inspector Comments: FS_ID:41786 DS_ID:22856 EP_NO: N/A FS_HLM: 5.216 Repair Type: Urgent Crossing Status: Found

Pipe open on WS slope.

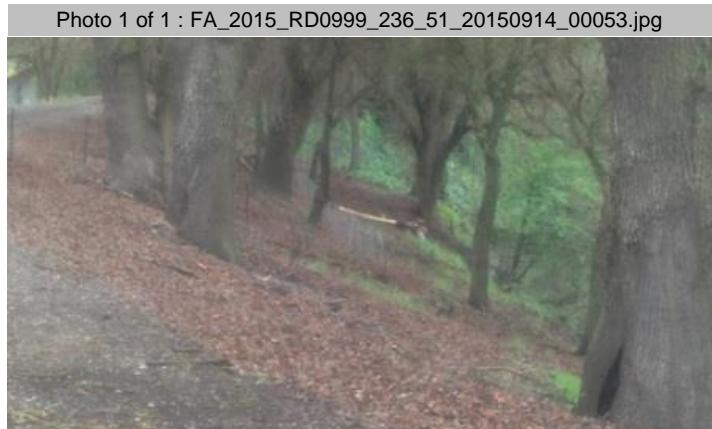
LM Start	5.38	Rating **	M	Issue No.	51							
LM End	5.42	Issue Type +	En	Location *	WS							
Category	Earthen Levee			GPS Latitude/Longitude								
				Start	End							
Item	Encroachments			38.381490 °	38.381795 °							
				-121.545477 °	-121.545996 °							
DWR ID	DWR_RD0999_05_s_2012_51											
Action/Comments												
Fence												
Inspector Comments:	Fence is installed down waterside slope.

Looking northeast at fence on waterside slope.

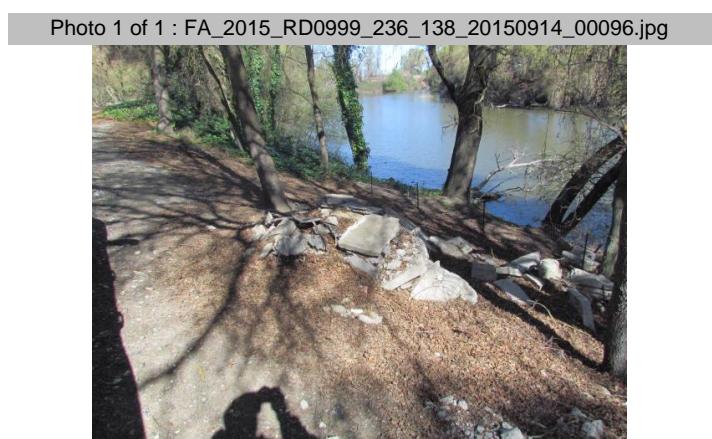
LM Start	5.41	Rating **	M	Issue No.	138							
LM End	5.41	Issue Type +	Ma	Location *	WS							
Category	Earthen Levee			GPS Latitude/Longitude								
				Start	End							
Item	Encroachments			38.381740 °	38.381740 °							
				-121.545864 °	-121.545864 °							
DWR ID	DWR_RD0999_05_s_2014_138											
Action/Comments												
Material												
Inspector Comments:	Concrete rubble dumped on waterward slope.

Looking northeast at concrete rubble on waterward slope.

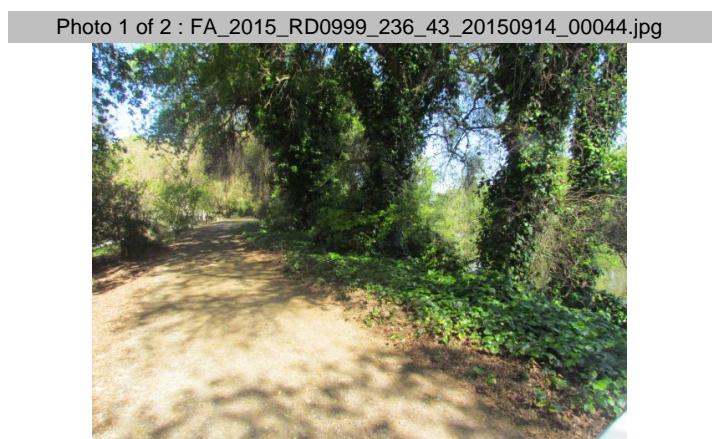
LM Start	5.42	Rating **	U	Issue No.	43							
LM End	5.44	Issue Type +	En	Location *	WS							
Category	Earthen Levee			GPS Latitude/Longitude								
				Start	End							
Item	Vegetation			38.381815 °	38.382137 °							
				-121.546058 °	-121.546338 °							
DWR ID	DWR_RD0999_05_s_2012_43											
Action/Comments												
Landscaping												
Inspector Comments:	Ground cover blocking view of waterward slope.

Looking north at dense groundcover and vegetation on waterward slope.
(Spring 2015)
